LIFE ASSESSMENT OF STEAM TURBINE – THE MICROSTRUCTURE AND GRAIN SIZE OBSERVATION OF TURBINE CASING

Amiral Aziz

Senior Mechanical Engineer for 10.000 MW Crass

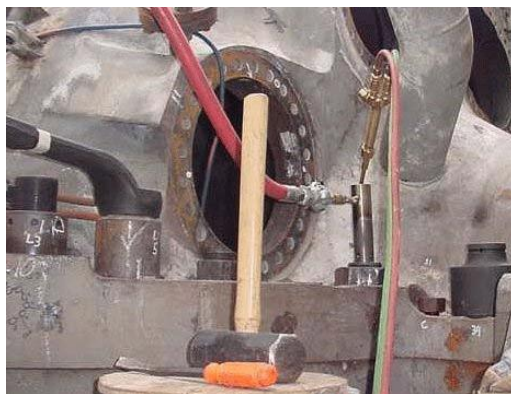
Figure. 4 Steam turbine casing
